NASA TM-100344

**STS-26 SOLID ROCKET BOOSTER POST FLIGHT
STRUCTURAL ASSESSMENT**

By David A. Herda and Charles J. Finnegan

**Structures and Dynamics Laboratory
Science and Engineering Directorate**

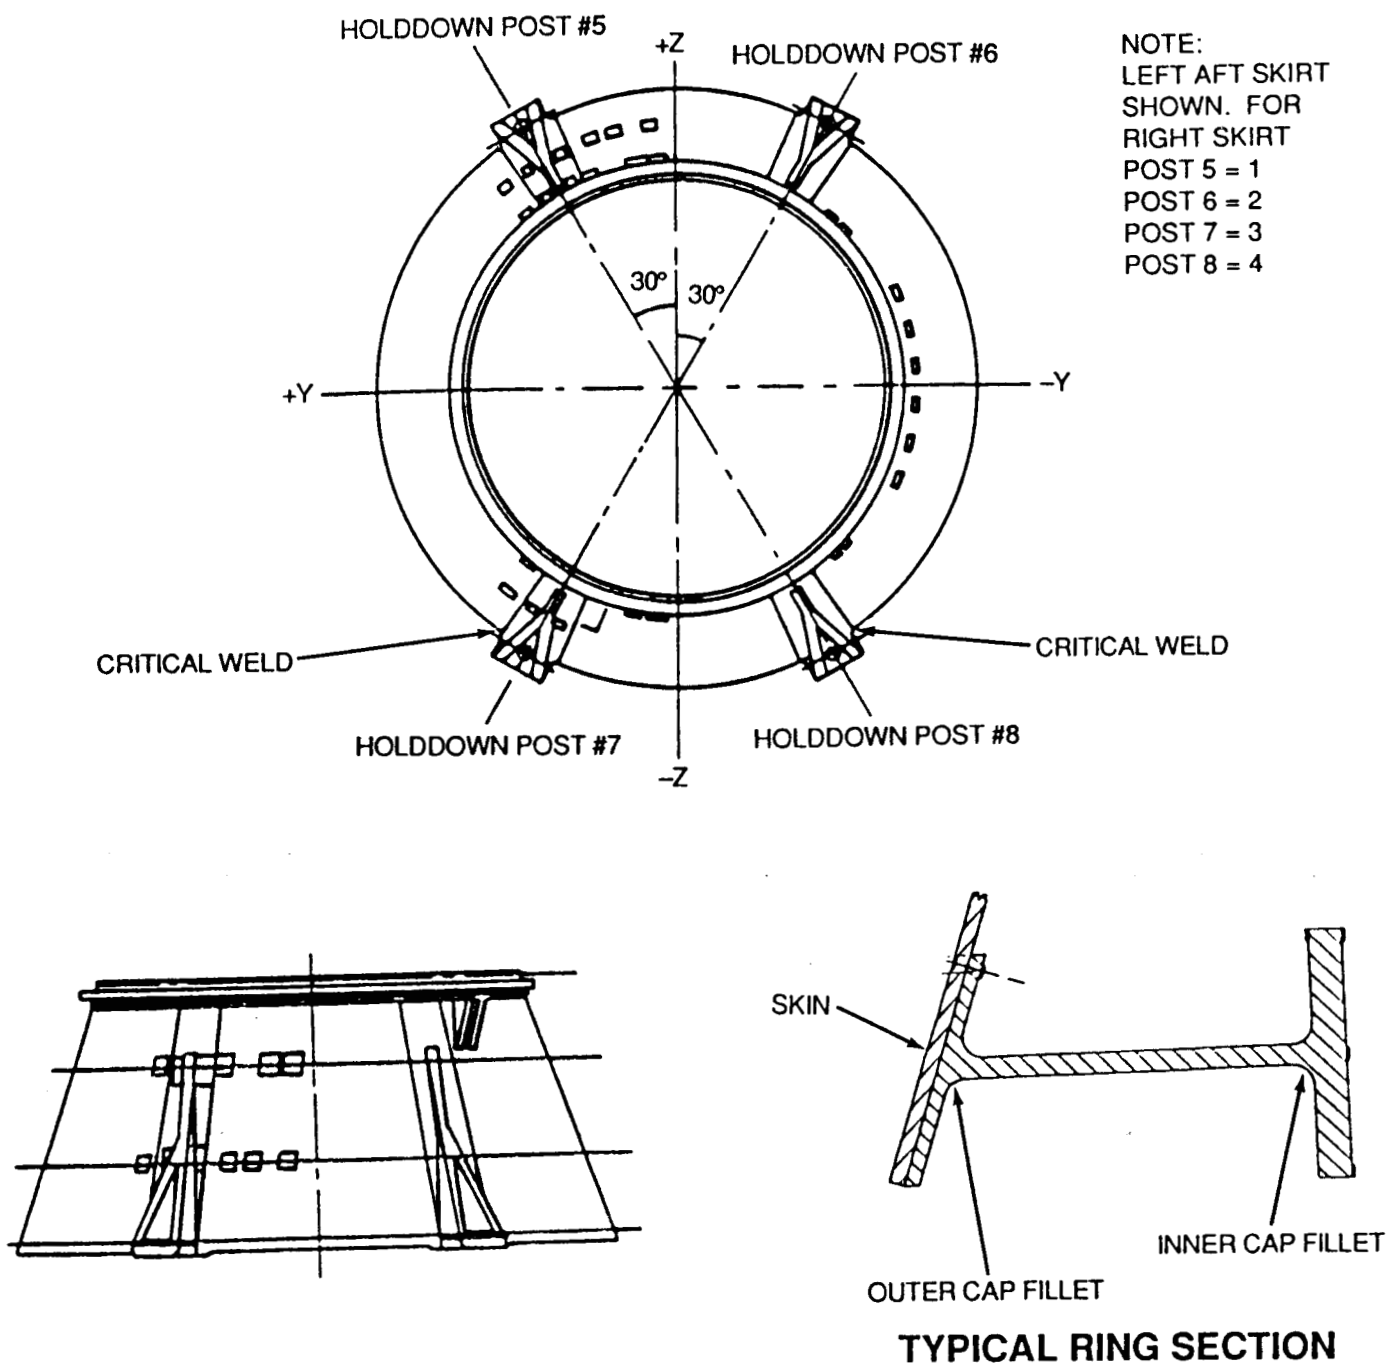
Figure 1. Aft Skirt structure.

1) Post-to-Skin Welds - Insulation was removed from the lower portions of the weld areas so that they could be inspected. No cracks were observed in any of the weld regions. A slight meridional scratch was noticed on the left side of post No. 7 on the left aft skirt however. The scratch was located adjacent to the weld/forging interface at approximately the elevation of the aft ring centerline. This was reported and subsequent non-destructive evaluation (NDE) will determine if this presents a problem.

2) Interior Rings - The aft side inner and outer flange-to-web fillets were inspected for cracking and/or deformation. No cracks or obvious deformation were observed. A paint crack approximately 8-in. long in the aft ring inner cap fillet at Rib No. 48 of the left skirt was found. This indicates that yielding or excessive deformation may have occurred. United Space Boosters, Inc. (USBI) agreed to request that further NDE be performed in this area. Gouges were also observed in the outer cap fillet of the right skirt at Rib No. 14. They appeared to be due to assembly or TPS removal and USBI agreed to document them on a problem report.

3) Ring-to-Skin Fasteners - Sealant caps were in place over all of the fasteners. There was no evidence of sheared bolts on any of the rings.

4) Gussets - Each gusset was visually checked and showed no sign of buckling.

5) Horizontal and Vertical Tabs - The connections of the hold-down post tabs to the aft ring were checked and no sheared fasteners were found.

6) Forging - The footpad holes showed no signs of broaching (caused by improper stud ejection) and the tension post footpads showed no obvious signs of dishing.

7) Kick Ring Bolts - All of the inner and outer kick ring bolts were in place. Sealant covered each bolt, thus precluding further inspection.

8) Forward Ring Weld - Foam covered the inside surface of the weld and insulation covered the outside, thus preventing an inspection.

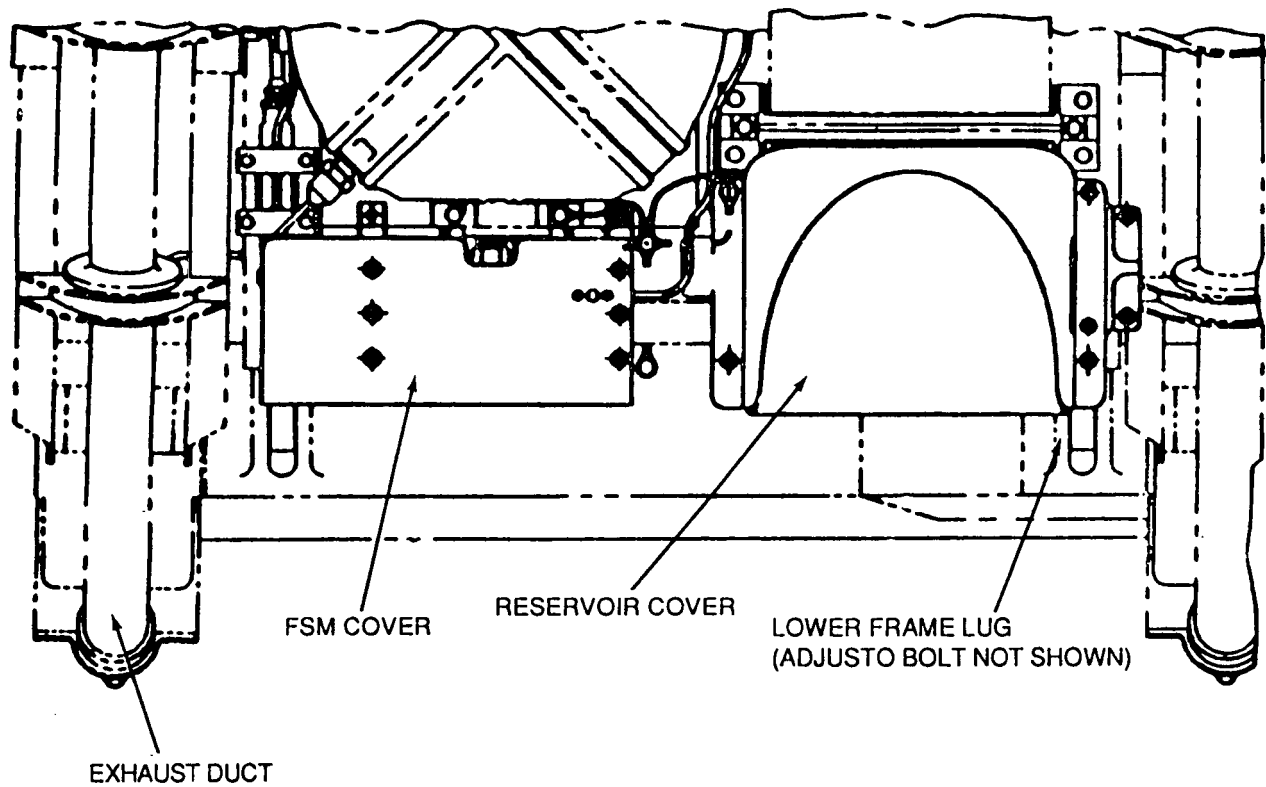
Figure 2. Thrust Vector Control System hardware.

The TVC hardware was inspected and no signs of structural damage were found. Particular attention was given to the adjust bolts and lugs that secure the lower frames to the aft ring; the fuel supply module (FSM) guard and attach brackets; the hydraulic reservoir guard and attach brackets; and the exhaust duct.

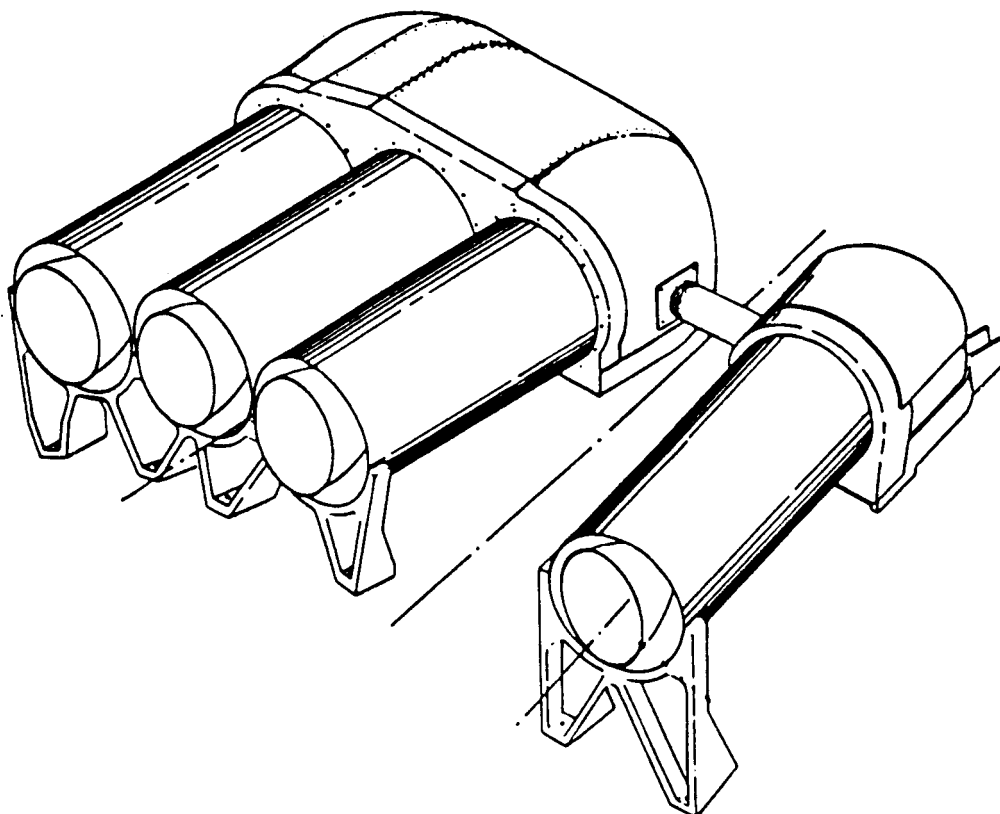
Figure 3. Aft Booster Separation Motors mounted on Aft Skirt.

The aft BSM support structure was inspected and no damage to the frames was observed. All bolts were also in place.

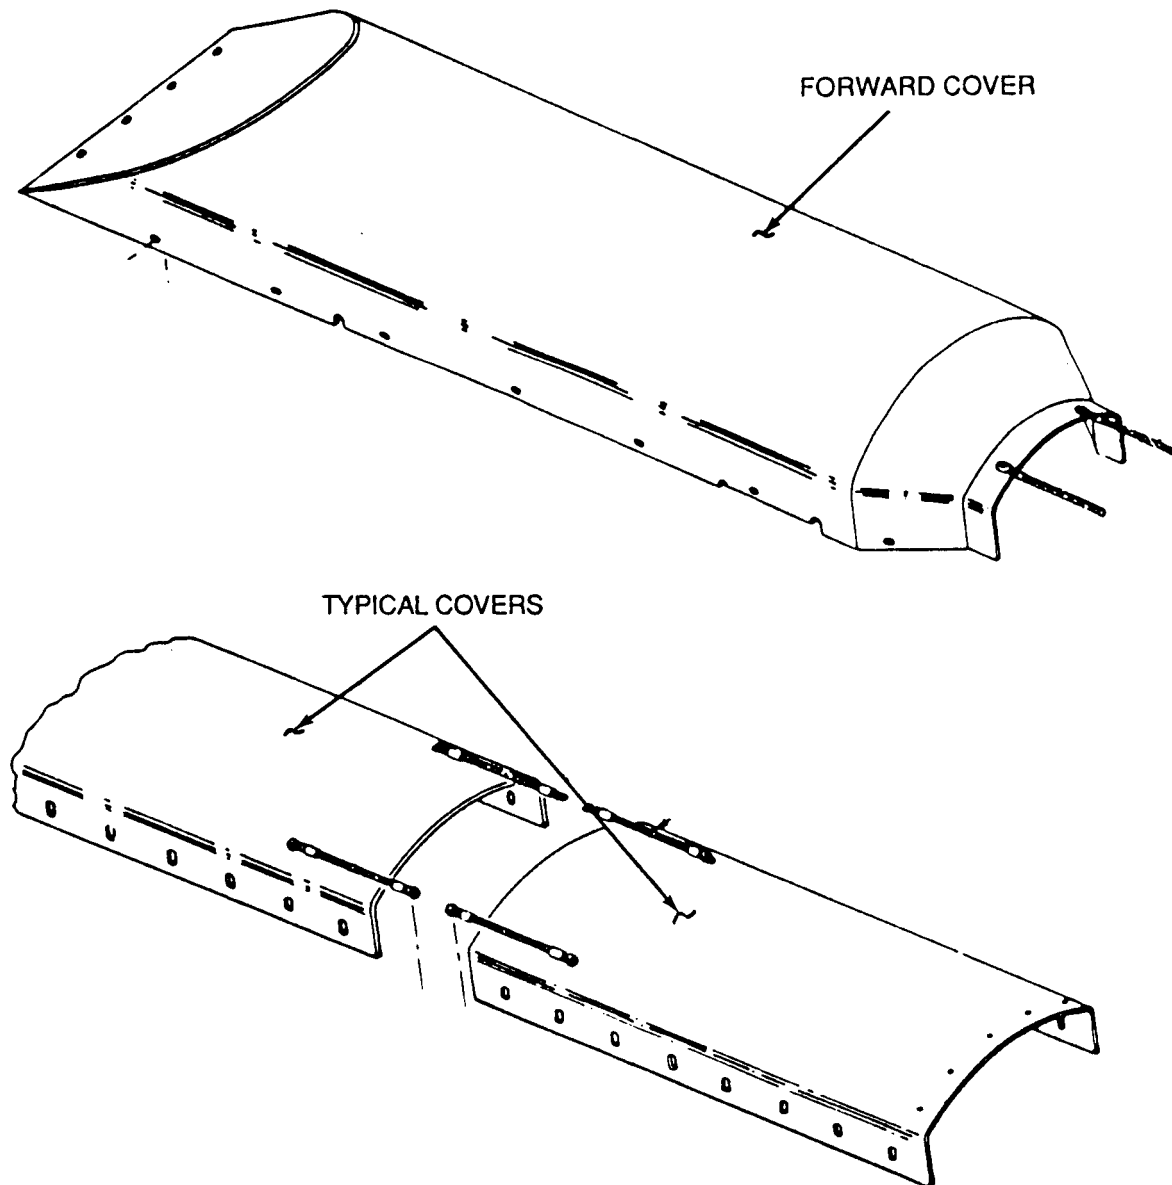
Figure 5. Systems Tunnel Covers.

The systems tunnel of each SRB was visually inspected while the boosters were intact on the rail cars. No damage was observed to either tunnel prior to cover removal. The auxiliary K5NA tunnel that contained the field joint heater cables was intact. A complete inspection of the covers and floorplates after cover removal was not done. However, no obvious structural damage was reported.

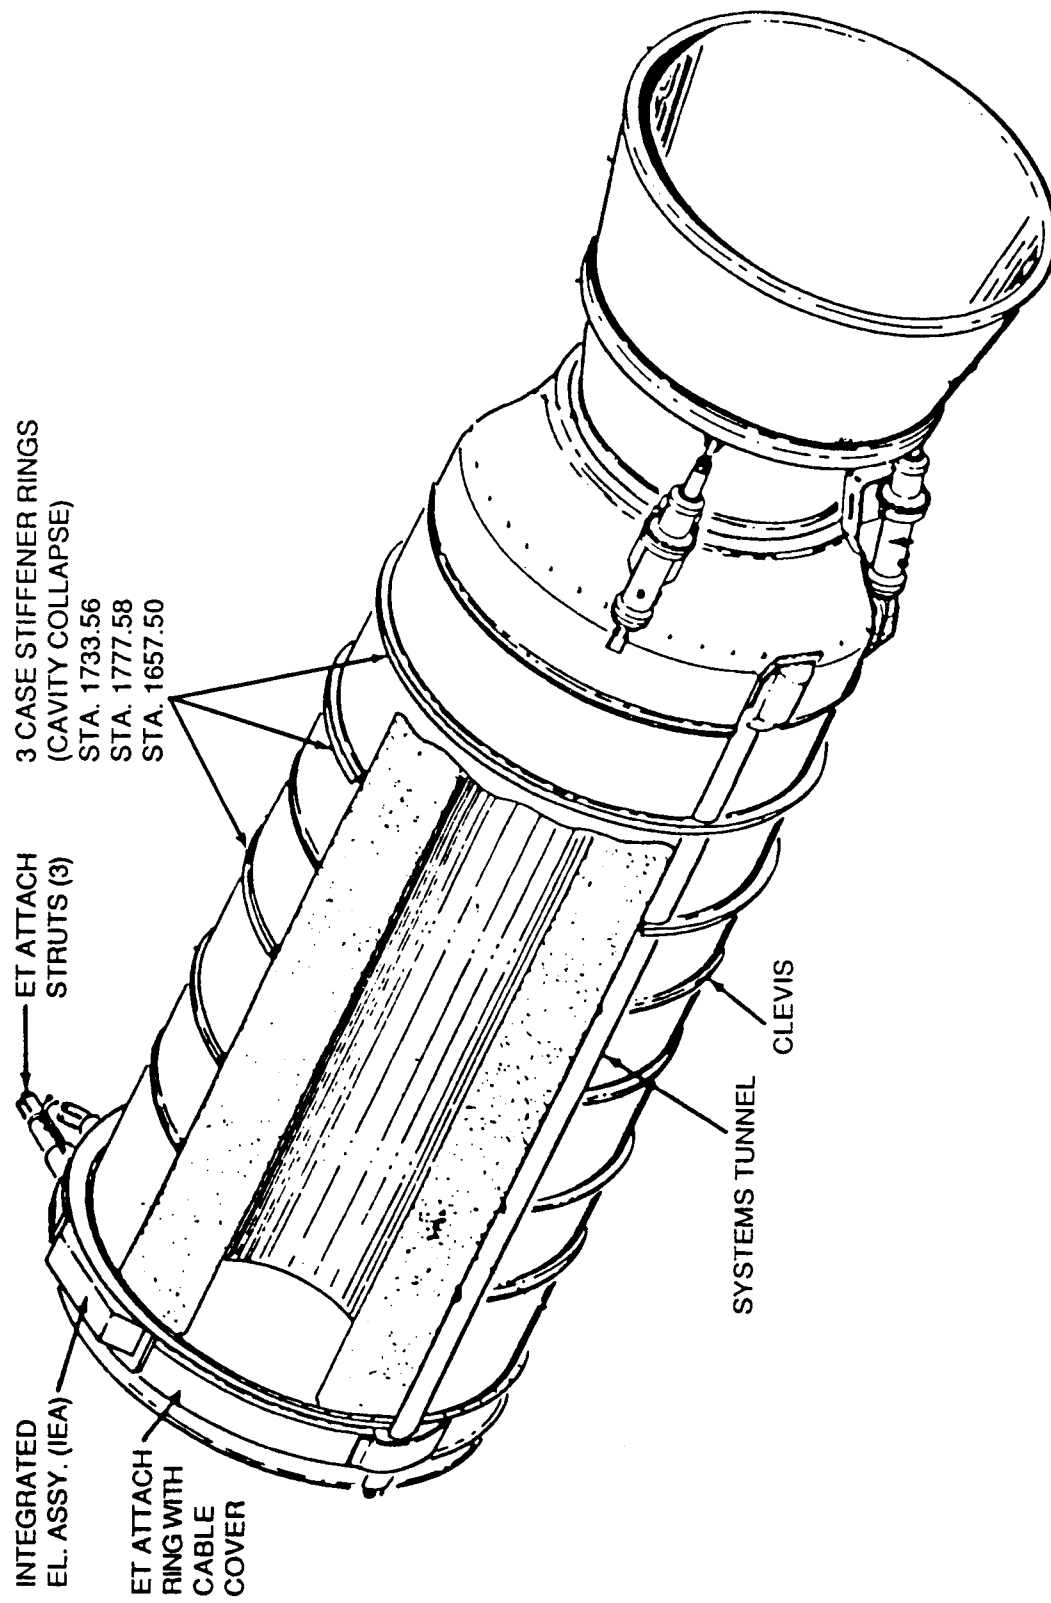
Figure 6. SRM Aft Segment.

The video tape of water impact showed a large geyser of water moving up one side of the left-hand booster. The right-hand booster had a smaller, less spectacular entry. We hypothesized the left-hand booster stiffener rings would sustain more damage. The complete opposite proved to be true. On the left side, the stiffener rings and their fasteners were in good condition. No structural damage was observed. All three stiffener rings on the right-hand booster were damaged. The following is a list of the damage sustained.

1) Forward ring — The ring was bent radially inward approximately 0.50 in. at the 160-deg location. A 3-in. crack through the bolt hole was evident in the web at this location. Also, 38 fasteners in the area had failed in shear.

2) Center ring — The ring was bent radially inward approximately 0.25 in. at the 160-deg location. A 5-in. crack through the bolt hole was evident in the web at this location. A total of 30 fasteners failed in this area.

3) Aft ring — The ring had a 7-in. crack through the bolt hole and continuing along the stiffener ring web. A total of 20 fasteners failed in this area.

All three rings had local buckling on either side of the damaged area. Typically, this out-of-plane deformation of the web would occur about 20 deg away from the crack centerline. This buckling was caused by the inward displacement of the ring which put part of the web in compression. These areas corresponded to the same locations where cracks were observed on the motor case stiffener ring stubs.

Permanent deformation was observed in many of the holes on all three rings in the vicinity of the cracks and buckled regions. This indicates that the rings carried a large in-plane load which was probably caused by cavity collapse pressure on the motor case.

The insta-foam on the aft side of the three stiffener rings was missing from 130 to 190 deg. This indicates that the water impact loads were high in this location.

The ET attach rings were visually inspected prior to removal from the motor case and after disassembly. Before removal, the condition of the insta-foam on the rings could be inspected. The foam on the forward edges was rough and discolored, but in good condition. No metal was exposed. Both rings had a section of insta-foam missing on the aft side. There was approximately 60 deg of foam missing, exposing the rings. This area was clean and not covered in soot as was the other hardware in the vicinity. The missing foam location corresponded to the foam damaged on the three stiffener rings aft of the ET attach ring. Apparently the damage was caused by cavity collapse at water impact.

The hardware on the rings was in good condition. All of the splice plates and web-to-tang holes were inspected, and no cracks or deformation were evident. The paint sealer between the cap and the web was checked for cracks, which would indicate relative motion between the parts, no cracks were noted. Some of the fasteners in the critical splice areas were saved for metallurgical examination. Visually the fasteners appeared in good condition, without deformation.

Possible damage was seen on a right-hand SRB intercostal. Paint was missing from the intercostal and the adjoining web, appearing as if there was contact between them. However, this could be the result of damage encountered during retrieval. The IEA cover was missing in this region, thus the intercostal was exposed to sea water during towback. Also, several cables were loose in this area and they could have contacted the intercostal.

The In-Harbor Tow Bracket on the left-hand SRB was bent forward about 1 in., also the six bolts which attach the bracket to the motor case tang were sheared. These bolts fasten the ET attach ring web to the tang. The adjoining lightning covers on the attach ring, which attach to the bracket, also sustained damage. This problem was the result of the SRB contacting the recovery ship during the retrieval process. As the ship was negotiating a turn, high swells pushed the SRB into the hull. The ship's fenders, designed to prevent this situation, were not adequate.

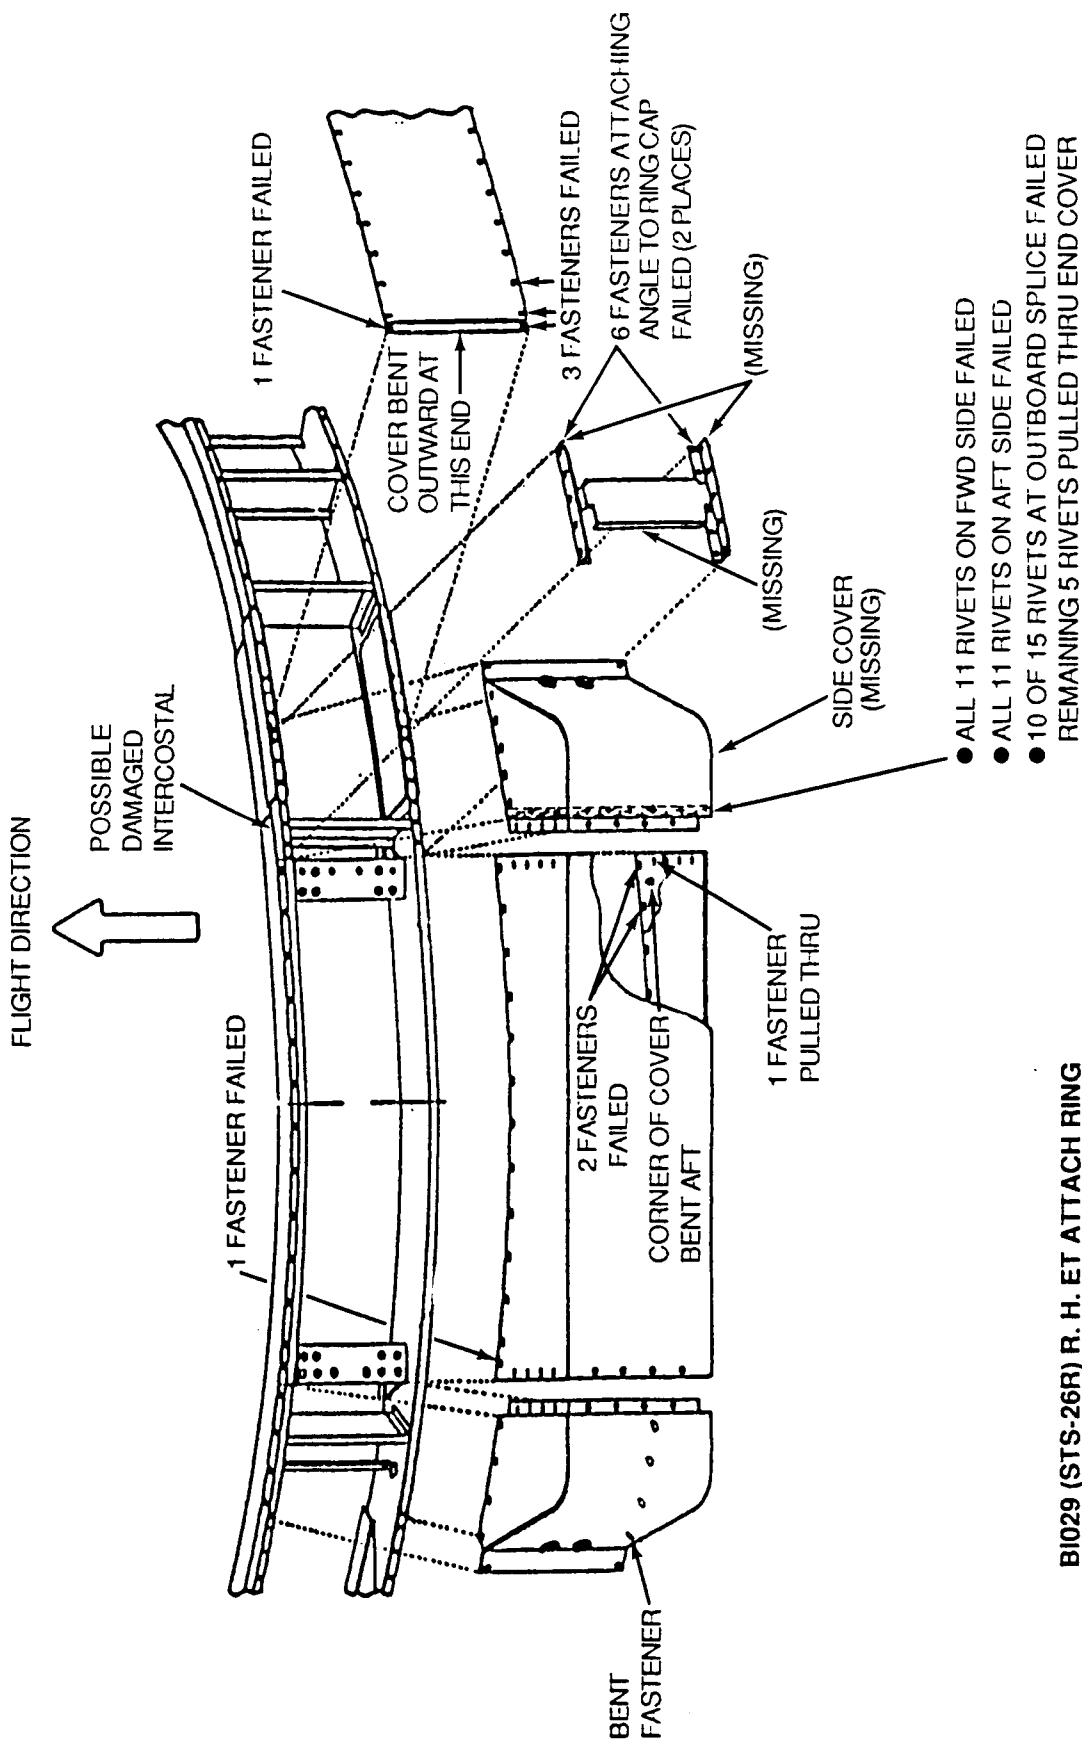
Figure 7. IEA Box damage.

One of the IEA box side covers on the right-hand SRB was missing. This cover has the same circumferential location as the damaged stiffener rings. All 37 rivets which attach the side cover to the center cover had failed, also the twelve 0.25-in. bolts which fasten the side cover to the cap were sheared. The damage appears to have been caused by water impact. The failed fasteners indicated that the cover was moving forward; this load is what would be expected during splash down due to the water spray. The cleanliness of the IEA box and the inside surfaces of the ET attach ring also suggest water impact. This area is exposed with the side cover off. The adjacent hardware is heavily sooted in this vicinity. Other damage was also evident as a result of the cover failure. The connecting lightning cover was bent and four fasteners had failed. Also, the center portion of the IEA cover was bent with three broken fasteners. Figure 7 summarizes the damage to the IEA box area.

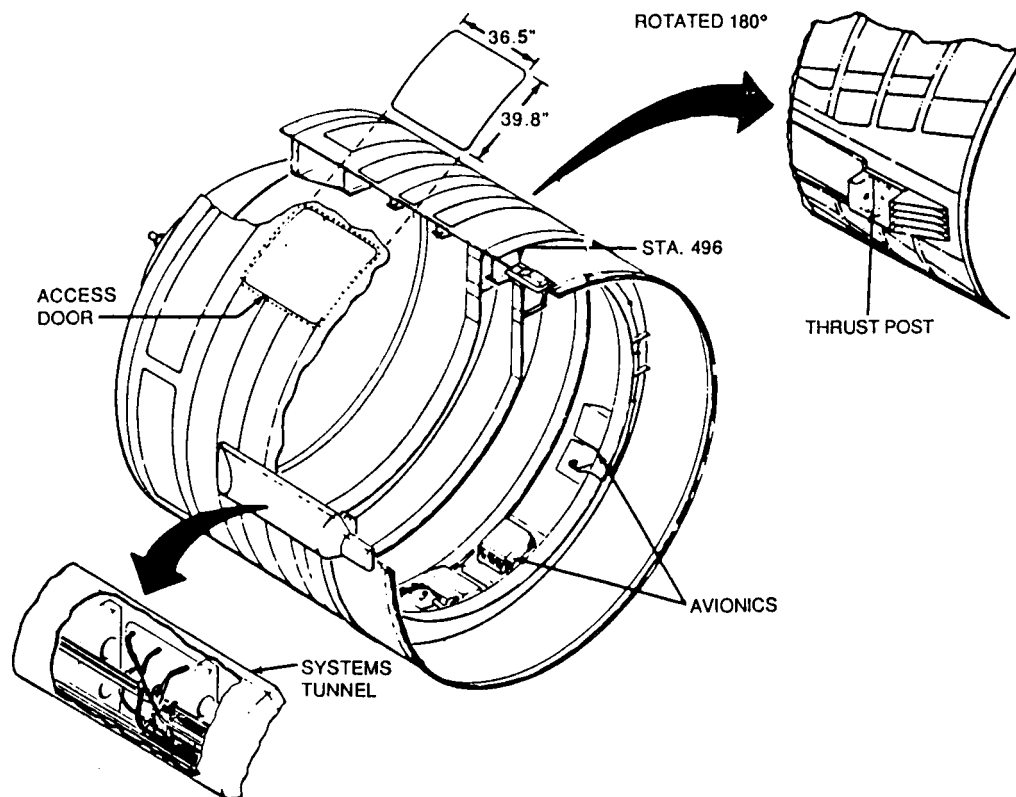
Figure 9. Forward Skirt Assembly.

No damage was observed to either forward skirt. The areas checked were: the dome, camera assembly, exterior thrust post, systems tunnel floor, interior skin, lower clevis pin holes, the access door area, interior structural rings and beams, interior welds, and the weld between the access door J-stiffener and the upper ring web at the parachute attach point location.

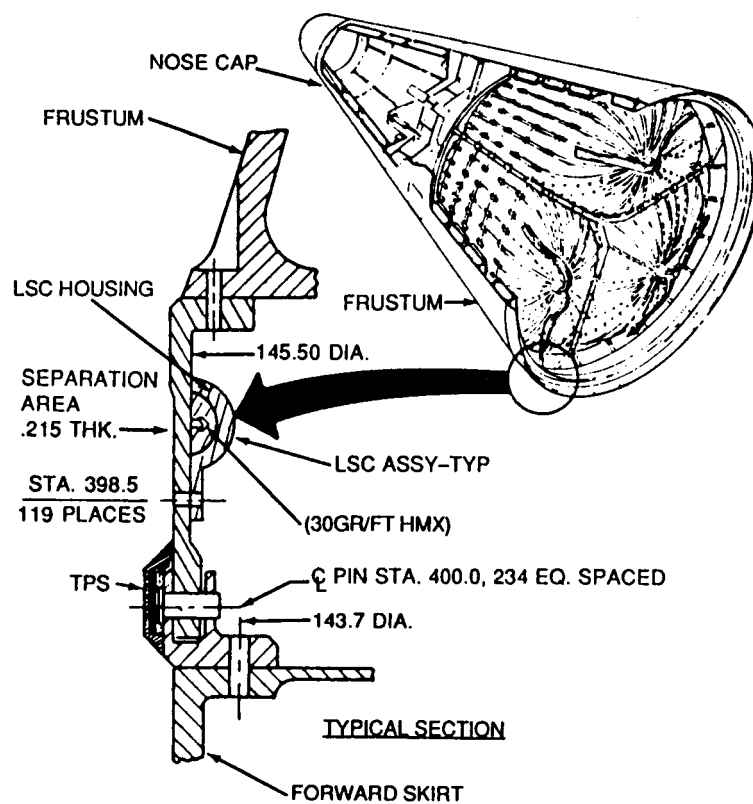
Figure 10. Ordnance Ring Assembly.

The structural parts of the ordnance ring appeared to function normally. The fracture plane was clean and no obvious deformation was seen in the lower pin holes that mate with the forward skirt.

The linear-shaped charge (LSC) housing of each ring assembly was severely damaged, however. The housing failed at numerous locations around the circumference of the ring. Bolts that secure it to the ring pulled through the slotted holes in the housing in many places and the housing holes were excessively damaged.

This condition has been observed on previous flights and is caused by the blast pressure of the LSC. None of the housing sections actually came off but some almost did. This is a concern because a loose piece of metal that size could possibly cut a parachute line.

The LSC housing is reinforced intermittently by backup plates. All of the damage was seen in the spans between reinforcements. A possible fix would be to add more backup plates to shorten the unreinforced spans.

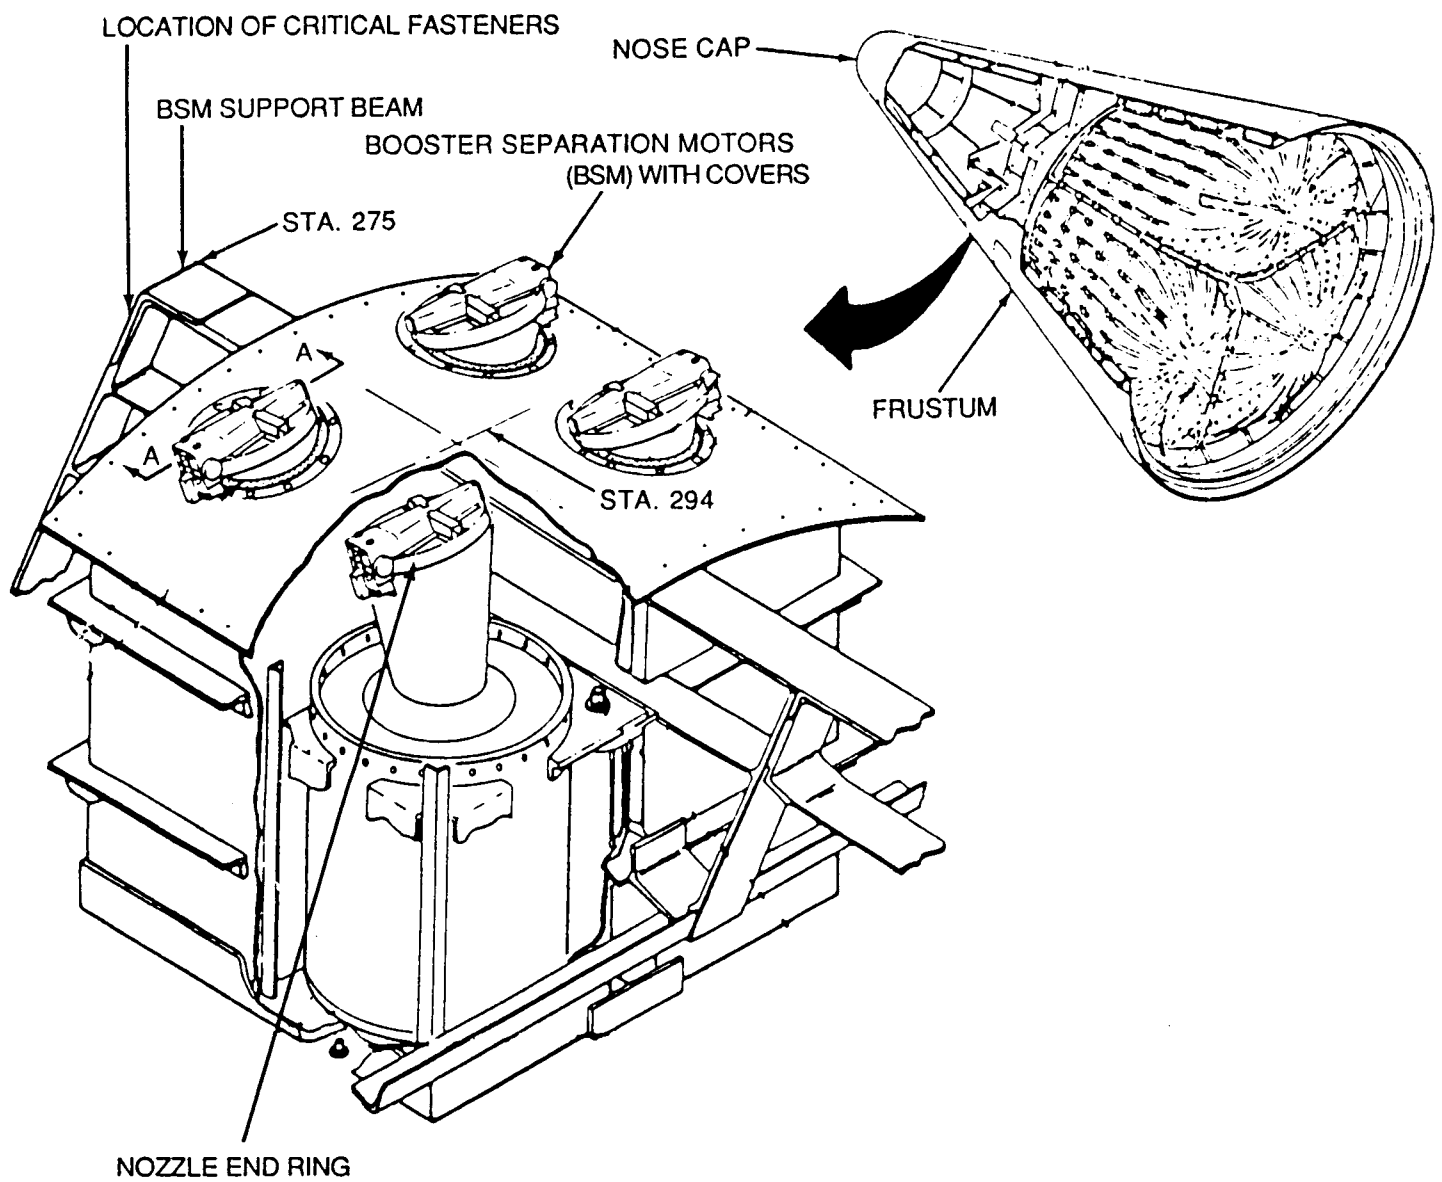
Figure 11. Frustum with Forward BSMs.

The interior of each frustum was inspected and no damage was seen. Due to low margins of safety, shown in the USBI Frustum Stress Analysis (USBI-ANAL-74-87), a request was made to remove four bolts that connect the top ring of the frustum to the BSM support beam. These fasteners are loaded in tension during flight and will be sent to USBI-Huntsville for evaluation, following removal. Sealant caps covered the fasteners during the inspection, indicating that the bolts were still in place.

The four motors in each frustum showed significant yielding in the flange around the edge of the nozzle exit cone. No dimpling or distortion of the nozzle surface was seen, however. The end ring that bolts to the nozzle flange also showed significant yielding in the corresponding locations. This condition is expected and is caused by the torque put on the ring by the opening of the exit cone cover at BSM ignition.

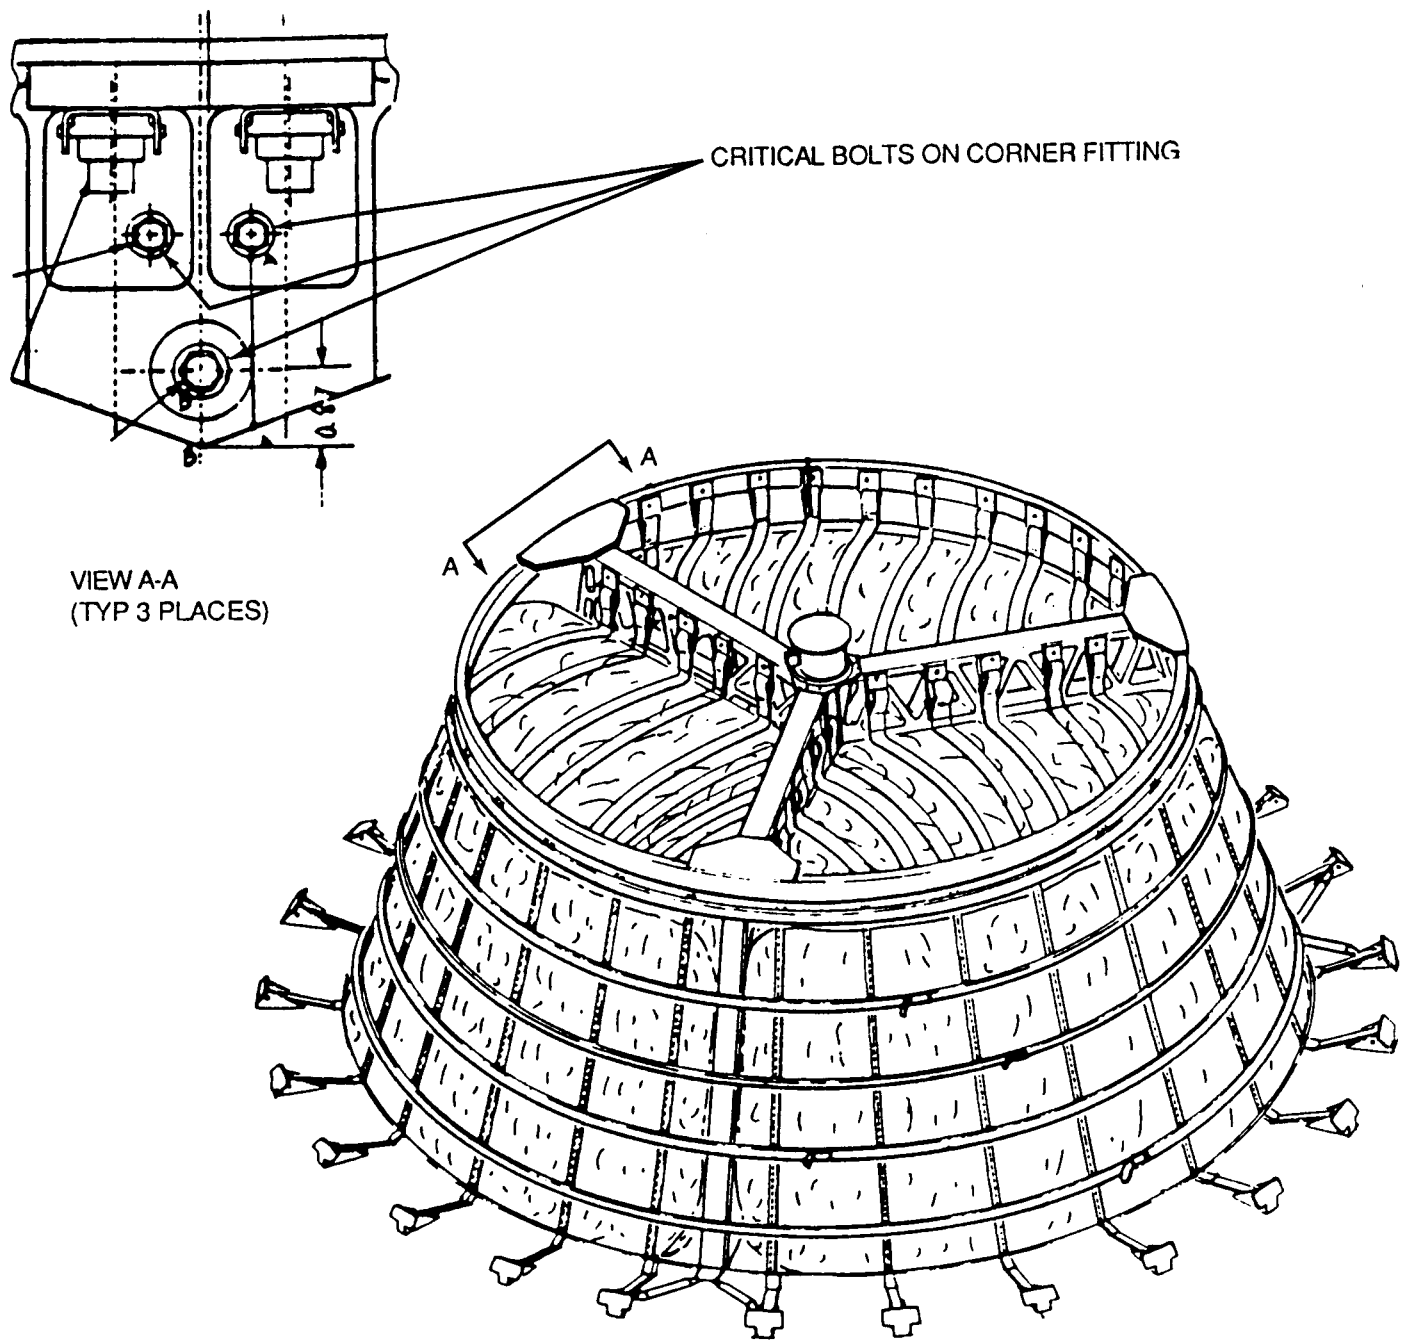
Figure 12. Main Parachute Support Structure
with parachutes in place.

The isogrid structure in each frustum supports the main parachutes prior to deployment. The corner fittings that are part of the attachment of the isogrid to the frustum see a high inertial load at frustum separation. Three fasteners at each corner fitting were shown to have negative margins of safety in shear bearing in the USBI Decelerator Subsystem Stress Analysis (BPC-ANAL-61-87). Paint cracks around the sealant caps on several of these bolts were observed and a request was made to remove nine corner fitting bolts from each isogrid assembly so that the holes could be inspected for deformation. USBI concurred with this request and the data will be sent to USBI-Huntsville and MSFC for evaluation.
